NASA TECHNICAL
MEMORANDUM

WELDING ENERGY RELATED TO MICROSTRUCTURE
AND METALLURGICAL PROPERTIES OF 2014
ALUMINUM ALLOY PLATE

By Ray A. Dyke and John Sliffe*
Manufacturing Engineering Laboratory

*George C. Marshall
Space Flight Center,
Huntsville, Alabama*

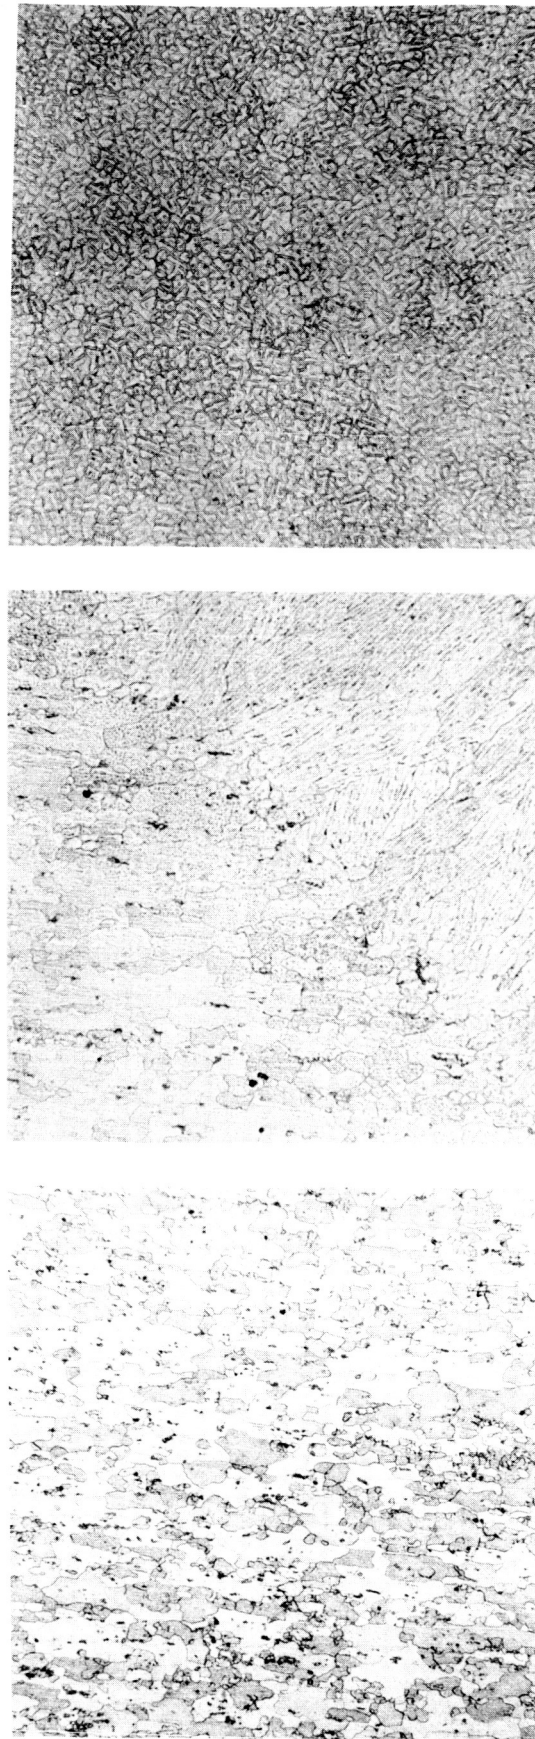
FIGURE 10. PLATE GTA WELDED BY METHOD A - ROOT CRACKS IN WELDS

Figure 10 shows the point of origin of a crack produced at the root of the continuous tack pass weld using the Method A technique. The same type cracking occurs after the first weld pass. All panels for this program were welded in an unrestrained condition. There were no cracks found in panels welded by Methods B and C. Transverse samples were prepared for metallographic examination after each weld

pass from all panels. Panels were radiographically inspected after each weld pass. The root cracks present in Method A welds were not detectable by radiographic inspection. The x-ray photographs showed no indication of cracks since the image of the crack is obliterated by the greater image of the unwelded portion of the joint. The cracks were not detected until metallographic specimens were prepared for examination after the continuous tack and the first weld pass. Welds by all three methods were x-ray-acceptable after the final pass. To assure weldment reliability, panels from each technique were sectioned into 32 segments, each 0.625-inch wide, and radiographed at right angles to the original direction of inspection. This examination showed two segments with possible defects in one panel welded by Method A. The two segments were sectioned through the possible defect areas, polished, etched and examined at a magnification of 20 diameters. These two areas had slightly higher macro-porosity than adjacent areas, but no defects that would adversely affect radiographic quality. It is imperative that all possible defect areas be carefully investigated. This is particularly true with welds. No cracks may be tolerated. Therefore, it is expected that the above type of investigation is the minimum effort to be expended to assure the reliability of this system.

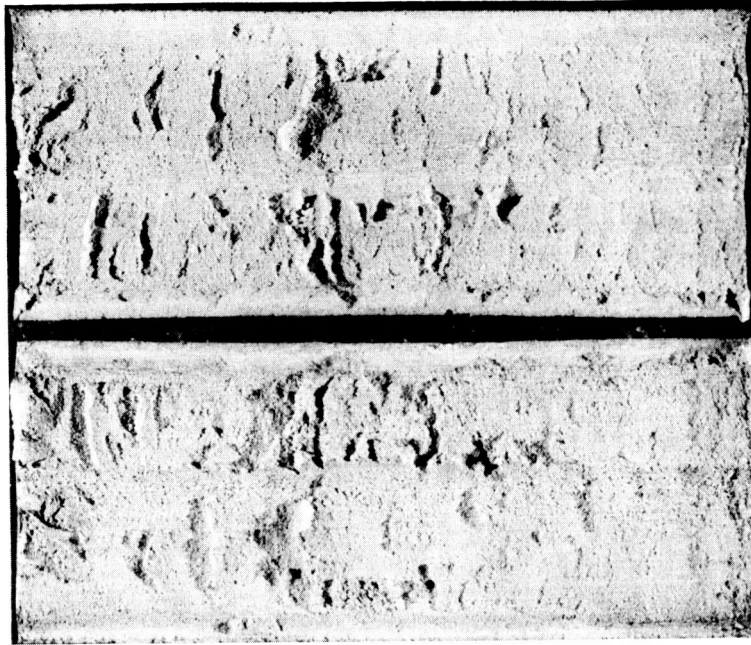
FIGURE 14. TENSILE SPECIMEN FROM PLATE GTA WELDED BY METHOD B

View Looking Down on the Fracture Face of the Tensile Bar
at the Junction of the Weld and Heat Affected Zone.

Macroetched Surface of a Section Showing the Area of the
Greatest Discontinuity of Tensile Specimen

The fracture face of a conventional tensile specimen from a panel welded by Method B is shown in Figure 14. A macroetched section was prepared from the area of the fracture with the greatest surface irregularity. This type of fracture is typical for welds of 2014-T6 plate with the weld shaved or with the top of the weld nearly flush with the plate surface. If the welds are reinforced, the fracture normally occurs in the "primary" heat-affected zone.

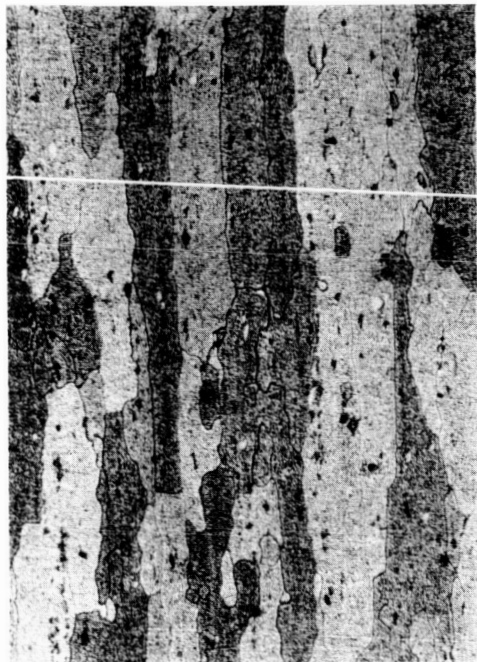
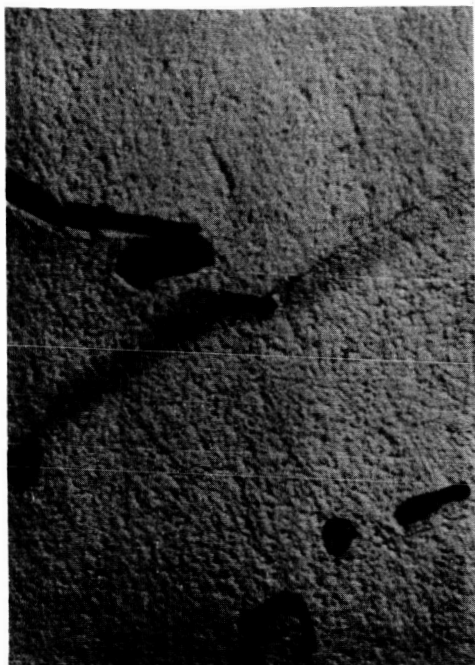
X100

Etched in Keller's Reagent

X500

The center of a 0.625-inch thick plate panel nine inches long by 24 inches wide was heated by holding an arc at controlled energy. The energy was concentrated on a spot with the electrode buried below the surface of the plate. An automatic welding machine with infra-red penetration control sensor was used. This technique produced a wide heat-affected zone. The demarcation of the fusion line was very pronounced, as shown in Figure 26. Figure 27 shows some of the microprecipitates produced by this high energy exposure. A unique crystalline formation occurred on the fusion line. Several of these massive particles, 0.03 inches long by 0.02 inches wide, were analyzed by x-ray diffraction and electron beam microanalysis, and found to be a complex compound of Al-Fe-Mn-Si. The microprobe analysis of these particles was 65 percent aluminum, 15 percent manganese, 15 percent iron, 2 percent silicon, and 2 percent copper. These formations were attributable to the redistribution or segregation of the components. The small coalesced particles in the recrystallized zone were essentially the same. The light etching zone, which had been partially melted, was lower in copper content than either the area in direct contact with the welding arc, the recrystallized zone, or the original plate. This experiment demonstrates the same copper migration phenomena that has been repeatedly observed in the study of microstructure produced from welding and weld repairing of 2014-T6 aluminum alloy plate.
